## **Julie Billiart School: Westlake Campus**

### **Preliminary Tree Preservation Report**

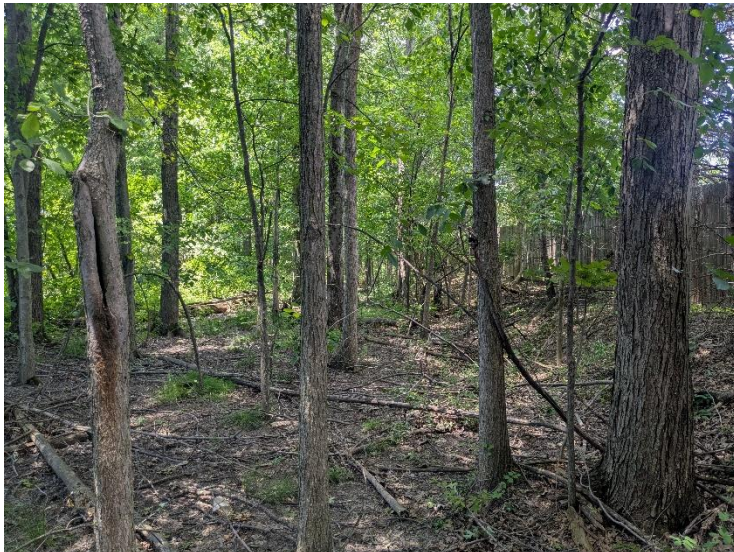
**Photo 1, left.** View of the existing site conditions of the southern woods buffer. (6/20/26)

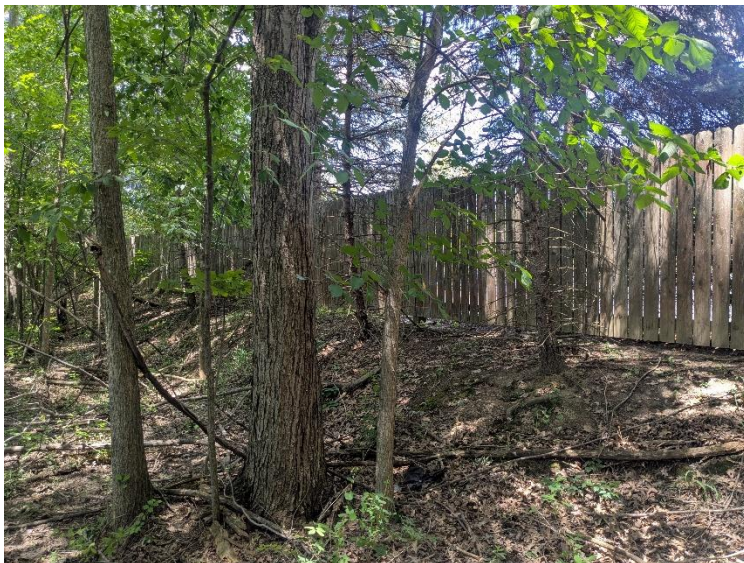
**Photo 2, left.** View existing site conditions of the fencing along the woods buffer in the southern portion of the property. (6/20/26)
